**Flood Control Project Maintenance  
Levee Inspections**

## Maintenance Issue Types Only, Levee Inspection Report By Mile - Spring 2018

### Sutter Maintenance Yard Maintenance Area 0005

Waterway	Bank	Unit Miles	Inspection Start/End	Inspector
Unit No. 01 Butte Creek	Left	15.08	03/14/2018 03/14/2018	Bob Duffey

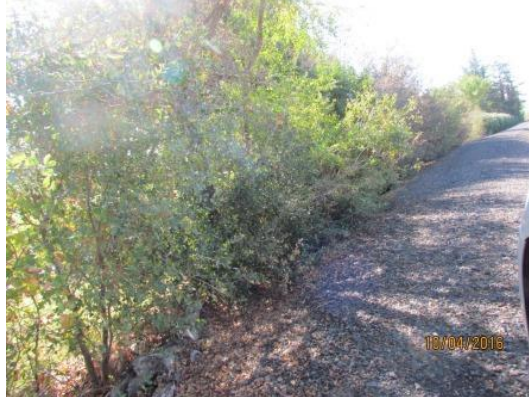
Photo 1 of 1 : SP\_2018\_MA0005\_196\_32\_20180305\_00012.jpg

LM Start	0.58	Rating **	M	Issue No.	32
LM End	0.68	Issue Type +	Ma	Location *	LS
Category	Earthen Levee			GPS Latitude/Longitude	
				Start	End
Item	Trim / Thin Trees			39.690496 °	39.689137 °
				-121.777109 °	-121.776938 °
DWR ID	DWR_MA0005_01_s_2014_32				
Comment Code					
T2 : Thin trees to allow visibility of the ground and room to flood fight.					
Inspector Comment

View of the trees along the landside toe blocking visibility.

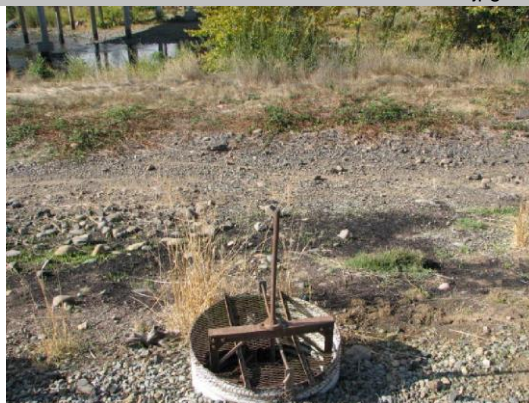
Photo 1 of 3 : UCIP\_SP\_2018\_51949\_67931.jpg

FS\_ID:51949  
DS\_ID:1616  
EP\_NO: N/A  
Repair Type: No Action Needed  
Crossing Status: Found  
UCIP Comments: 5/15/2017 Crossing appears to be in good condition. LS inlet is located in the Distribution box on the LS toe. This is an overflow pipe used to regulate water levels in side the box. Pipe has been selected to be internally cleaned and inspected as part fo the DMP project. (DWR Sutter Yard- AFreitag)11/15/2016 Crossing appears to be in good condition. (DWR Sutter Yard- AFreitag)5/9/2016 Crossing appears to be in good condition.8/5/2015 WS pipe end is being overgrown by trees and other vegetation. Needs to be cleared back.12/8/2014 Same as last inspection.6/11/2014 Same as last inspection.11/20/2013 Same as last inspection.5/29/2013 Same as last inspection.  
FIELD\_STRUCT\_DESC: 24-inch corrugated metal drainage pipe through the levee, 16.5 feet below the crown. Slide gate in a corrugated metal riser on the waterside (WS) slope. Flap gate on the WS toe. Inlet on the landside (LS) toe, not found. [Additional Reference(s): DWR Levee Log, 1990. USACE Sacramento O&M Manual 516, April 1960, (Station 381+36)].

CMP riser and slide gate on WS shoulder.

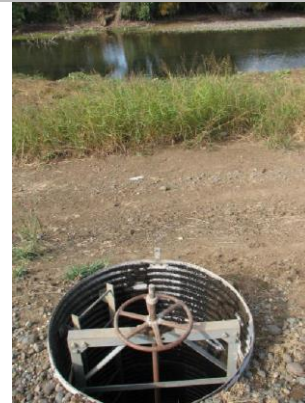
Photo 2 of 2 : UCIP\_SP\_2018\_51955\_67940.jpg

FS\_ID:51955  
DS\_ID:1620  
EP\_NO: N/A  
Repair Type: Non-Urgent  
Crossing Status: Found  
UCIP Comments: 5/15/2017 Abandoned and needs to be done properly. A sink hole formed in the WS toe road and revealed the location of the WS pipe end. Sink hole will need to be repaired before the next high water season but the pipe has been selected to be internally cleaned and camera inspected as part of the DMP project so it will have needed to be excavated along the WS end anyways. (DWR Sutter Yard- A Freitag) 11/15/2016 Abandoned. Needs cover for the standpipe. (DWR Sutter Yard- A Freitag) 5/9/2016 Abandoned pipe. Needs a cover for the standpipe. 8/5/2015 Abandoned crossing. Covers need to be made for tops of standpipes to prevent falls. 12/8/2014 Same as last inspection. 6/11/2014 Same as last inspection. 11/19/2013 Same as last inspection. 5/29/2013 Same as last inspection. Land owner said pipes are abandoned and no longer used. Covers should be made for top of standpipe to prevent falls. Pipes should be properly abandoned. 10/30/2012 Pipe 1/2 filled with soil at slide gate end.

FIELD\_STRUCT\_DESC: \*ABANDONED\* 1 of 2: 36-inch drainage pipe through the levee, 11 feet below the crown. Slide gate in a 54-inch corrugated metal riser on the waterside (WS) slope. Concrete "U" headwall on the landside (LS). [Additional Reference(s): DWR Levee Log, 1990. Sacramento O&M Manual 516, April 1960 (Station 470+00)].  
FS Date: 5/31/2017 1:00:19 PM

54-inch CMP riser and slide gate on WS shoulder.

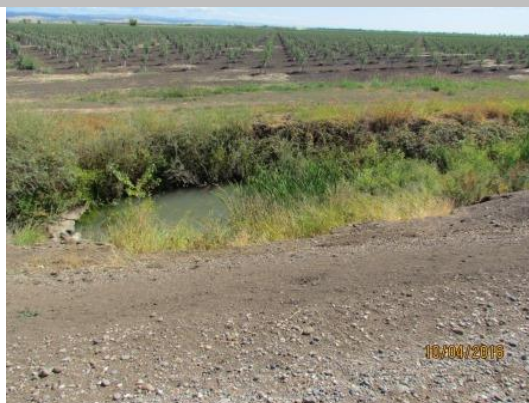
Photo 2 of 2 : SP\_2018\_MA0005\_196\_56\_20180305\_00030.jpg

LM Start	5.81	Rating **	U	Issue No.	56
LM End	5.81	Issue Type +	Ma	Location *	LS
Category	Earthen Levee			GPS Latitude/Longitude	
				Start	End
Item	Erosion / Bank Caving			39.621261 °	39.621261 °
				-121.773973 °	-121.773973 °
DWR ID	DWR_MA0005_01_f_2016_56				
Comment Code					
E2 : Schedule repair of erosion site prior to the next inspection.					
Inspector Comment

Another view of the landside toe erosion.

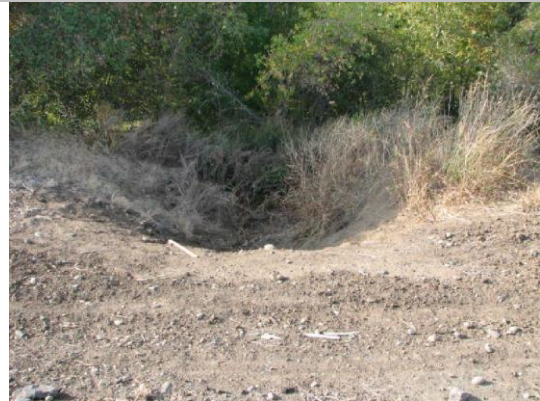
Photo 1 of 3 : UCIP\_SP\_2018\_51972\_67973.jpg

Outlet at WS toe.

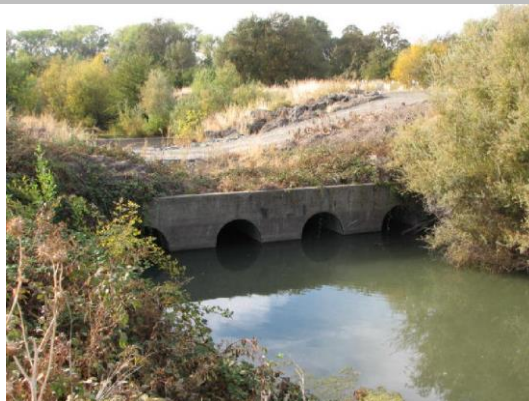
Photo 2 of 2 : UCIP\_SP\_2018\_51976\_67978.jpg

LS of pipe crossing.

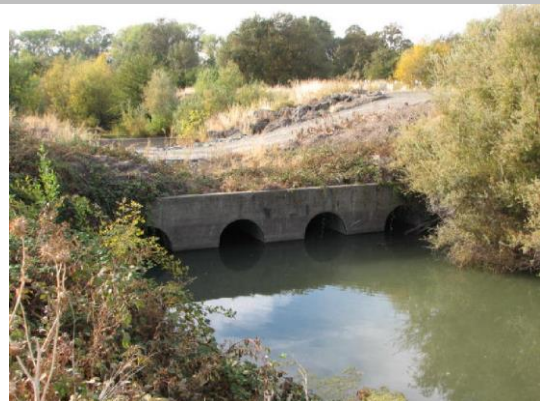
Photo 2 of 2 : UCIP\_SP\_2018\_51977\_67980.jpg

LS of crossing.

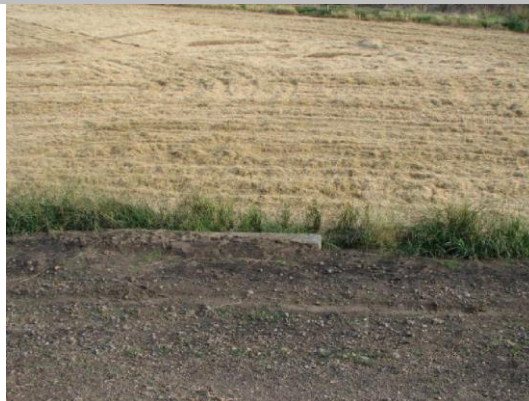
Photo 1 of 2 : UCIP\_SP\_2018\_51982\_67991.jpg

Concrete headwall at LS toe.

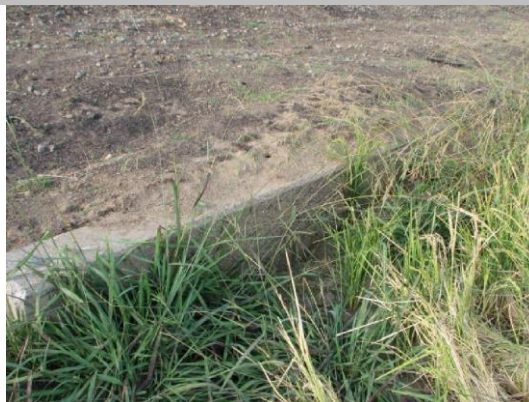
Photo 2 of 2 : UCIP\_SP\_2018\_51982\_67990.jpg

Concrete headwall at LS toe.

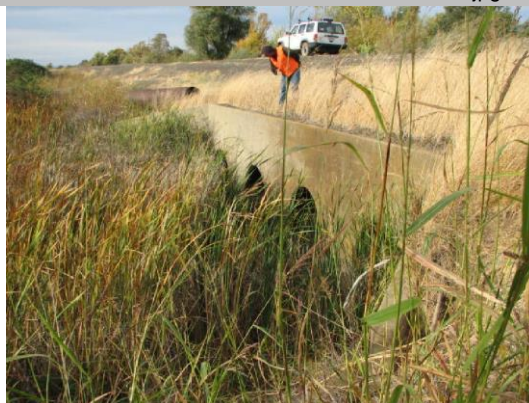
Photo 2 of 2 : UCIP\_SP\_2018\_51990\_68006.jpg

LS intake headwall.

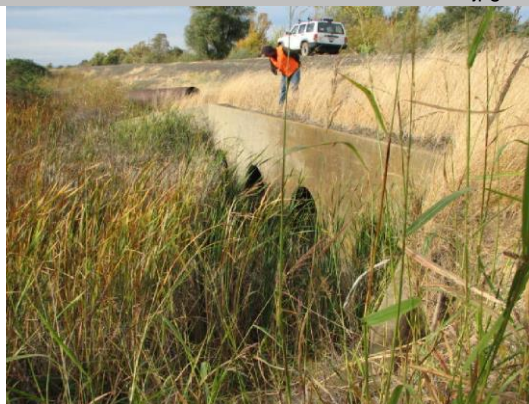
Photo 2 of 2 : UCIP\_SP\_2018\_51991\_68008.jpg

Headwall at LS toe.

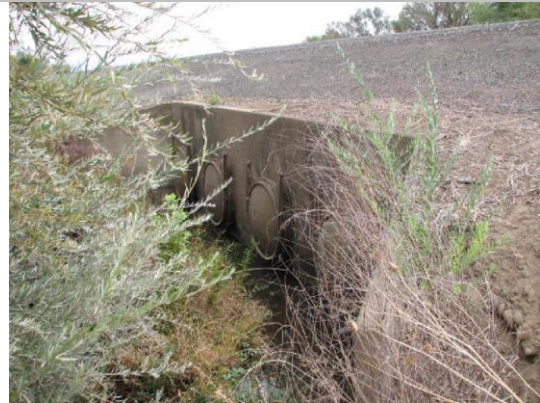
Photo 1 of 2 : UCIP\_SP\_2018\_51992\_68011.jpg

Headwall and flap gates at WS toe.

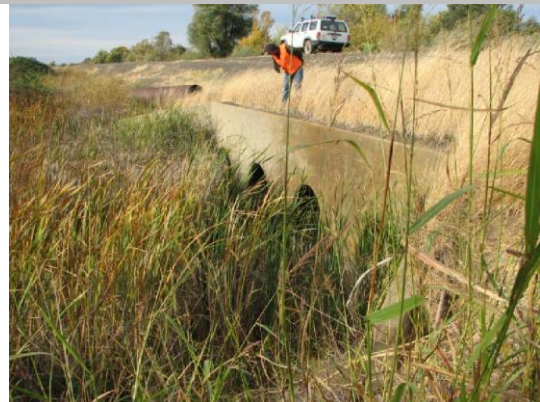
Photo 2 of 2 : UCIP\_SP\_2018\_51992\_68010.jpg

Headwall on LS toe.

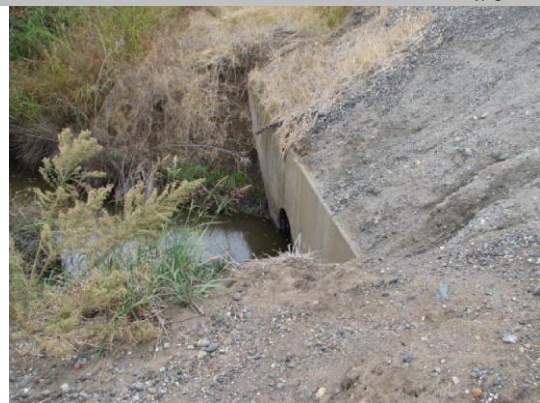
Photo 2 of 3 : UCIP\_SP\_2018\_51994\_68016.jpg

Concrete headwall on LS toe.

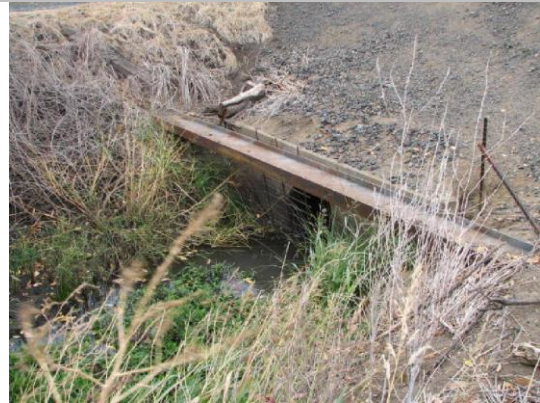
Photo 1 of 3 : UCIP\_SP\_2018\_51999\_68033.jpg

Headwall at inlet on LS toe.

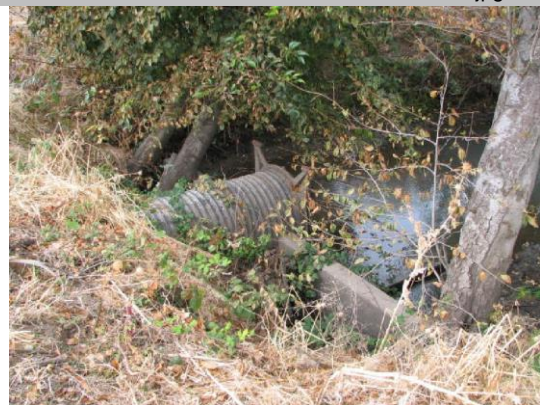
Photo 2 of 3 : UCIP\_SP\_2018\_51999\_68032.jpg

CMP pipe, flap gate, and headwall on WS toe.

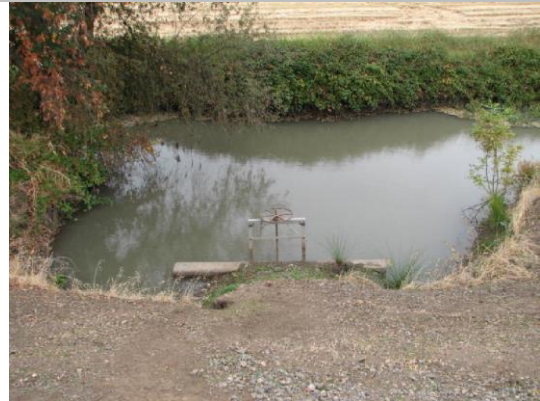
Photo 1 of 3 : UCIP\_SP\_2018\_52012\_68498.jpg

FIELD\_STRUCT\_DESC: 36-inch corrugated metal drainage pipe through the levee, 17 feet below the crown. Flap gate on the waterside (WS). Slide gate on the landside (LS) toe. Concrete headwalls at both the LS and the WS toes. [Additional Reference(s): DWR Levee Log, 1990. USACE Sacramento O&M Manual 515, (Station 902+50). USACE As-Built Drawing No. 50-4-2637, Exhibit B, Sheet 5, April 1950, (Station 902+50)].  
FS Date: 6/1/2017 9:42:13 AM

Concrete headwall and slide gate on LS toe.

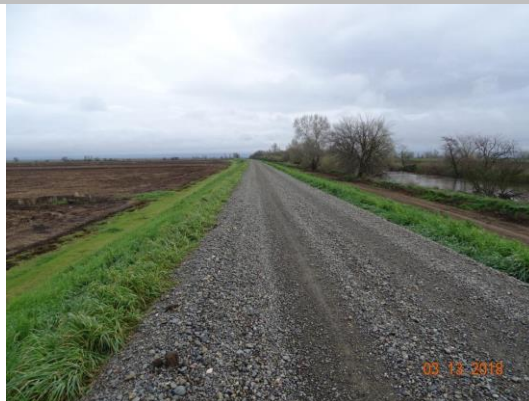
Photo 1 of 1 : SP\_2018\_MA0005\_197\_63\_20180402\_00098.jpg

LM Start	2.49	Rating **	A	Issue No.	63
LM End	2.49	Issue Type +	Ma	Location *	LS
Category	Earthen Levee			GPS Latitude/Longitude	
				Start	End
Item	Vegetation			39.544242 °	39.544242 °
				-121.846607 °	-121.846607 °
DWR ID	DWR_MA0005_02_s_2018_63				
Comment Code					
V1 : Control annual grass and weeds on the levee slopes and easements.					
Inspector Comment

View of native vegetation on both slopes.

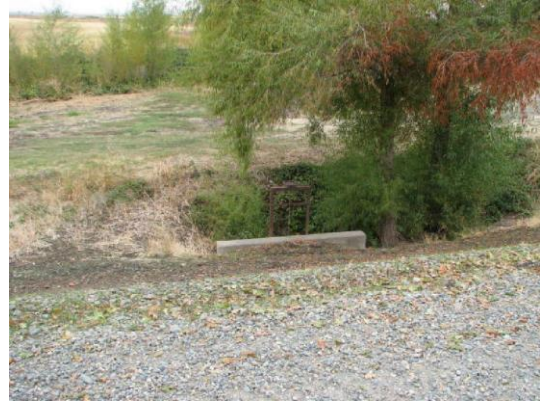
Photo 1 of 3 : UCIP\_SP\_2018\_52014\_68064.jpg

Concrete headwall and slide gate at LS toe.

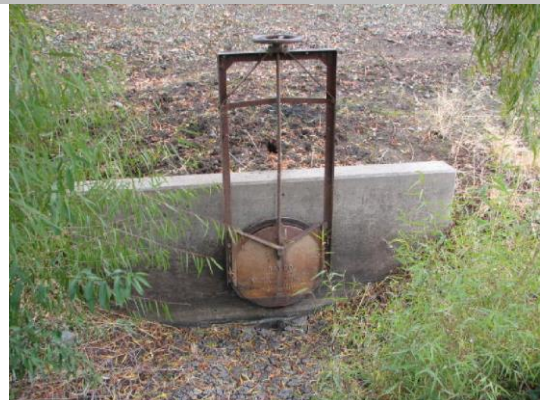
Photo 2 of 3 : UCIP\_SP\_2018\_52014\_68063.jpg

Concrete headwall and slide gate at LS toe.

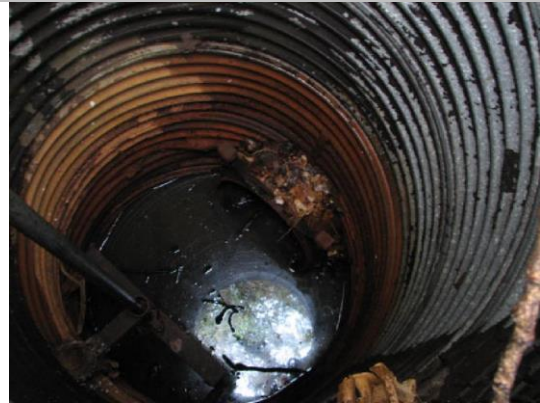
Photo 1 of 2 : UCIP\_SP\_2018\_52042\_68105.jpg

Slide gate and flap gate inside CMP riser on WS berm.

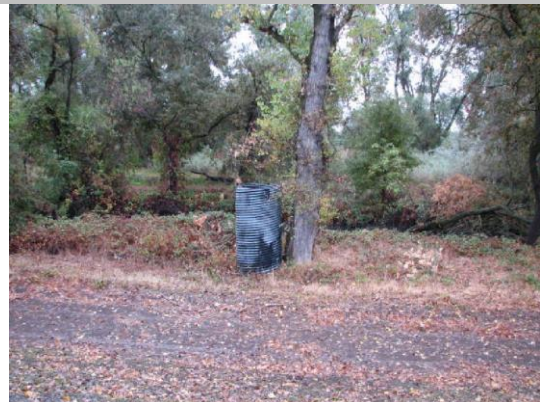
Photo 2 of 2 : UCIP\_SP\_2018\_52042\_68104.jpg

56-inch CMP riser on WS berm.

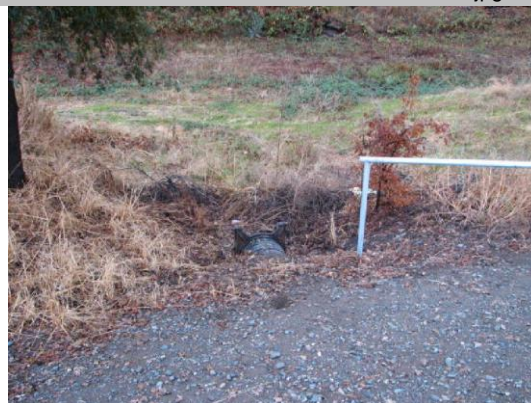
Photo 1 of 3 : UCIP\_SP\_2018\_52049\_68122.jpg

FS\_ID:52049  
DS\_ID:1654  
EP\_NO: N/A  
Repair Type: No Action Needed  
Crossing Status: Found  
UCIP Comments: 5/18/2017 Crossing appears to be in good condition. Pipe has been selected to be internally cleaned and inspected as part of the DMP project. (DWR Sutter Yard- A Freitag)11/14/2016 Crossing appears to be in good condition. (DWR Sutter Yard- A Freitag)5/23/2016 Crossing appears to be in good condition. 7/28/2015 Crossing appears in good condition. No noticeable issues to report. 11/24/2014 Same as last inspection. 6/04/2014 Same as last inspection. 11/12/2013 Same as last inspection. 6/6/2013 Same as last inspection.  
FIELD\_STRUCT\_DESC: 24-inch corrugated metal drainage pipe through the levee, 9.4 feet below the crown. Flap gate on the waterside (WS). Concrete headwalls at both the landside (LS) and the WS toes.  
[Additional Reference(s): DWR Levee Log, 1990. USACE Sacramento O&M Manual 515, April 1955, (Station 627+00). USACE As-Built Drawing No. 50-4-2637, Exhibit B, Sheet 3, April 1950, (Station 627+00)].

Flap gate on WS toe.

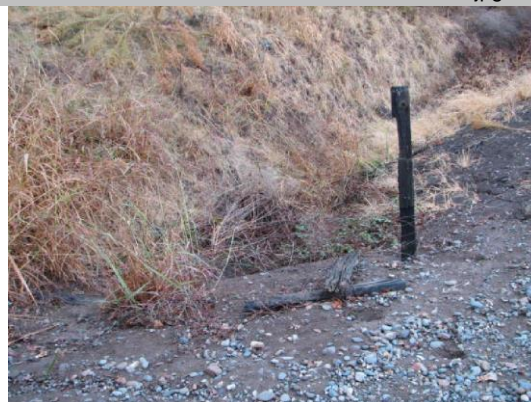
Photo 2 of 3 : UCIP\_SP\_2018\_52049\_68121.jpg

Headwall on LS toe.

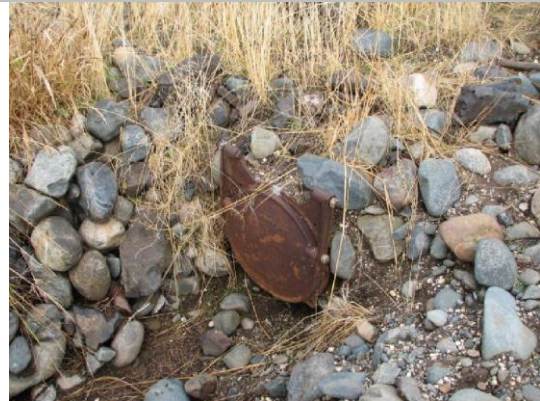
Photo 1 of 2 : UCIP\_SP\_2018\_52052\_68129.jpg

FS\_ID:52052  
DS\_ID:1656  
EP\_NO: N/A  
Repair Type: Non-Urgent  
Crossing Status: Found  
UCIP Comments: 5/18/2017 LS inlet is almost completely full of soil. Pipe has been selected to be internally cleaned and inspected as part of the DMP project. (DWR Sutter Yard- A Freitag)11/14/2016 LS inlet almost completely full of soil. (DWR Sutter Yard- A Freitag)5/23/2016 LS end is almost completely full of soil.7/28/2015 Pipe is still over 3/4 full of soil. 11/24/2014 Same as last inspection.6/04/2014 Same as last inspection.11/12/2013 Same as last inspection.6/6/2013 Same as last inspection.10/31/2012 Pipe 3/4 full with soil on LS.  
FIELD\_STRUCT\_DESC: 24-inch (not 18-inch as shown in as-built drawing) corrugated metal drainage pipe through the levee, 6.7 feet below the crown. Concrete headwall at the landside (LS) toe. Flap gate on the waterside (WS). [Additional Reference(s): DWR Levee Log, 1990. USACE Sacramento O&M Manual 516, April 1960, (Station 379+98). USACE As-Built Drawing No. 50-4-2637, Exhibit B, Sheet 2, April 1950, (Station 550+60)].

Flap gate at WS toe.

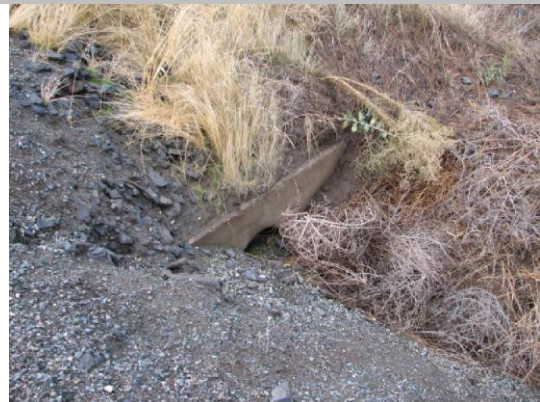
Photo 2 of 2 : UCIP\_SP\_2018\_52052\_68128.jpg

Concrete headwall on LS toe.

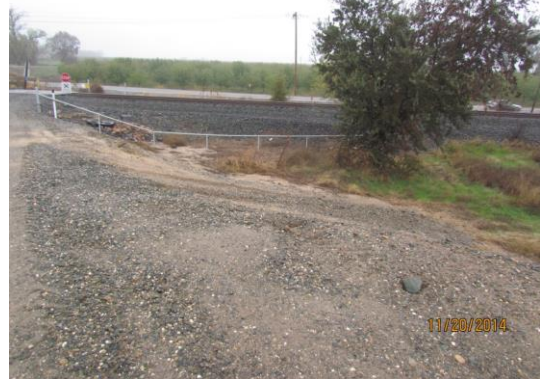
Photo 1 of 1 : SP\_2018\_MA0005\_197\_40\_20180305\_00016.jpg

LM Start	8.06	Rating **	M	Issue No.	40
LM End	8.06	Issue Type +	Ma	Location *	LS
Category	Earthen Levee			GPS Latitude/Longitude	
				Start	End
Item	Slope Stability			39.608563 °	39.608563 °
				-121.785058 °	-121.785058 °
DWR ID	DWR_MA0005_02_f_2014_40				
Comment Code					
S3 : Repair the levee slope damaged by vehicle traffic and prevent access where possible.					
Inspector Comment

View of the vehicle slope instability along the landside slope.

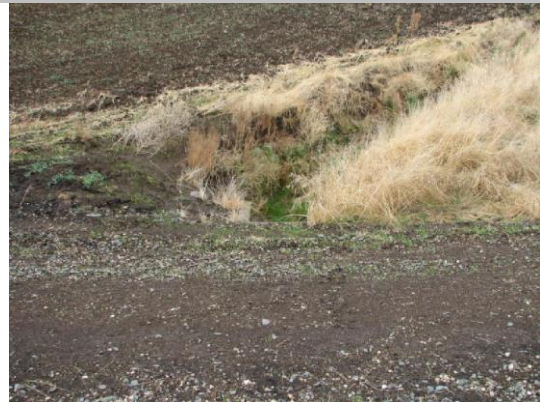
Photo 1 of 3 : UCIP\_SP\_2018\_52059\_68394.jpg

Comment Code					
Inspector Comment					
FS_ID:52059 DS_ID:1662 EP_NO: N/A Repair Type: No Action Needed Crossing Status: Found UCIP Comments: 5/18/2017 Crossing appears to be in good condition. Pipe has been selected to be internally cleaned and inspected as part of the DMP project. (DWR Sutter Yard- AFreitag)11/14/2016 Crossing appears to be in good condition. (DWR Sutter Yard- AFreitag)5/12/2016 Crossing appears to be in good condition.7/30/2015 Crossing is in good condition. No noticeable issues to report.11/24/2014 Same as last inspection.6/4/2014 Same as last inspection.11/13/2013 Same as last inspection..6/6/2013 Same as last inspection. FIELD_STRUCT_DESC: 30-inch corrugated metal drainage pipe through the levee, 16.3 feet below the crown. Flap gate on the waterside (WS). Concrete ""U"" shaped headwalls on both the landside (LS) and the WS. [Additional Reference(s): DWR Levee Log, 1990. USACE Sacramento O&M Manual 516, April 1960, (Station 374+90). USACE As-Built Drawing No. 50-4-3367, Exhibit B, Sheet 13, April 1957, (Station 374+90)]. FS Date: 6/1/2017 1:25:58 PM

Concrete inlet on LS toe.

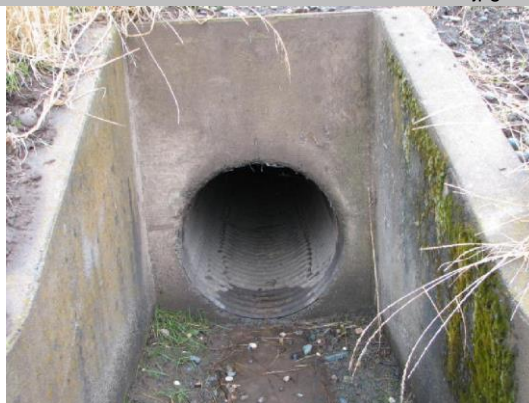
Photo 2 of 3 : UCIP\_SP\_2018\_52059\_68393.jpg

Concrete inlet on LS toe.

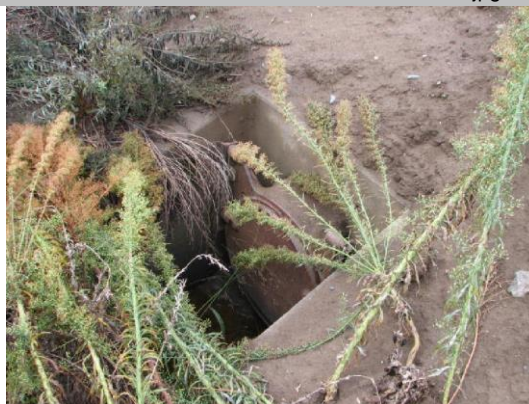
Photo 3 of 3 : UCIP\_SP\_2018\_52059\_68392.jpg

Concrete outlet and flap gate on WS toe.

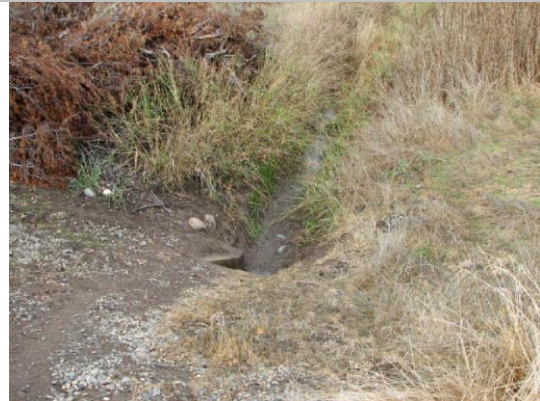
Photo 1 of 3 : UCIP\_SP\_2018\_52061\_68397.jpg

FS\_ID:52061  
DS\_ID:1663  
EP\_NO: N/A  
Repair Type: No Action Needed  
Crossing Status: Found  
UCIP Comments: 5/18/2017 Crossing appears to be in good condition. Pipe has been selected to be internally cleaned and inspected as part of the DMP project. (DWR Sutter Yard- A Freitag) 11/14/2016 Crossing appears to be in good condition. (DWR Sutter Yard- A Freitag) 5/12/2016 Crossing appears to be in good condition. 7/30/2015 Crossing appears in good condition. No noticeable issues to report. 11/24/2014 Same as last inspection. 6/4/2014 Same as last inspection. 11/13/2013 Damaged pipe section was dug up and replaced. New WS flapgate with u-shaped wingwall installed on end of pipe. 6/6/2013 Same as last inspection. Plans have been made to repair during summer of 2013 before high water season. 11/01/2012 Pipe rusted through along bottom at WS outlet. Sink hole over pipe on WS berm. WS headwall eroded eternally around backside of headwall.

Concrete U-shaped headwall on LS toe.

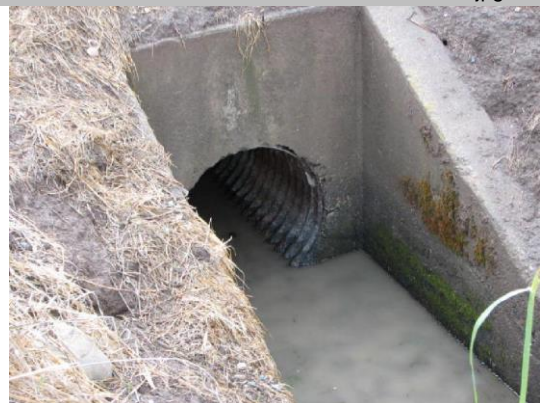
Photo 2 of 3 : UCIP\_SP\_2018\_52061\_68396.jpg

Concrete U-shaped headwall on LS toe.

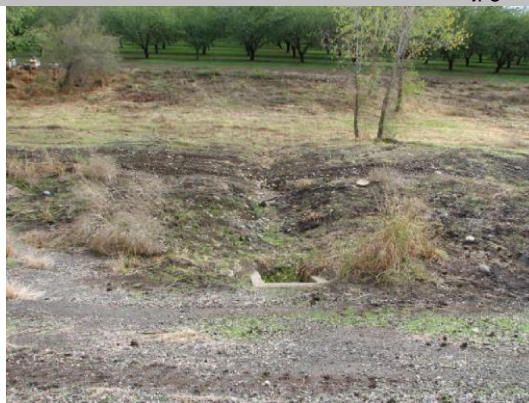
Photo 1 of 3 : UCIP\_SP\_2018\_52062\_68406.jpg

FS\_ID:52062  
DS\_ID:1664  
EP\_NO: N/A  
Repair Type: Non-Urgent  
Crossing Status: Found  
UCIP Comments: 5/18/2017 No LS slide gate but not sure its even needed. Pipe has been selected to be internally cleaned and inspected as part of the DMP project. (DWR Sutter Yard- AFreitag)11/14/2016 LS slide gate still missing. Rest of crossing appears in good condition. (DWR Sutter Yard- AFreitag)5/12/2016 LS inlet was unburied. Slide gate still missing7/30/2015 LS inlet is still buried.11/24/2014 Same as last inspection.6/4/2014 Same as last inspection.11/13/2013 Same as last inspection.6/6/2013 Same as last inspection.11/01/2012 LS inlet is buried under soil and covered with brambles. Slide gate missing from LS.  
FIELD\_STRUCT\_DESC: 24-inch corrugated metal drainage pipe through the levee, 12 feet below the crown. Flap gate on the waterside (WS). Concrete headwall on the WS. Concrete headwall on the landside (LS), not found. [Additional Reference(s): DWR Levee Log, 1990. USACE Sacramento O&M Manual 516, April 1960, (Station 338+04). USACE As-Built Drawing No. 50-4-3367, Exhibit B, Sheet 11, April 1957, (Station 338+04)].

WS outlet and concrete U shaped headwall.

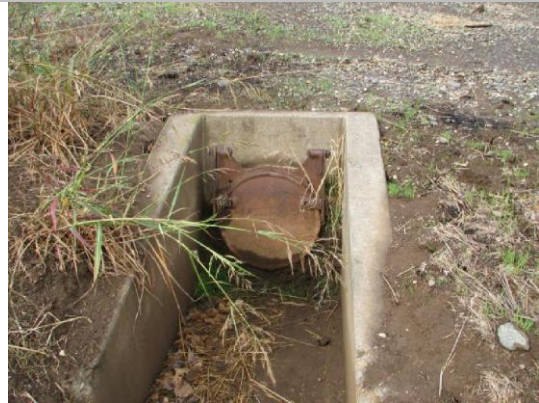
Photo 3 of 3 : UCIP\_SP\_2018\_52062\_68403.jpg

Concrete U shaped headwall and flap gate at WS toe.

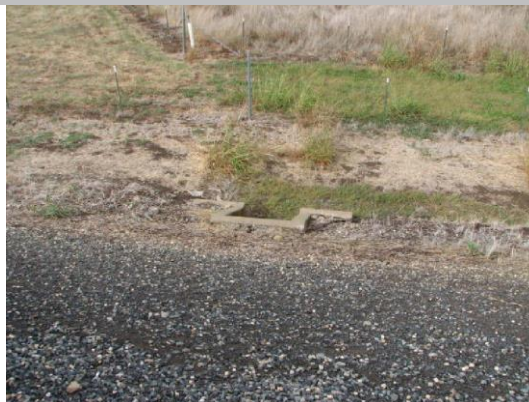
Photo 2 of 3 : UCIP\_SP\_2018\_52063\_68412.jpg

Concrete U shaped headwall on LS toe.

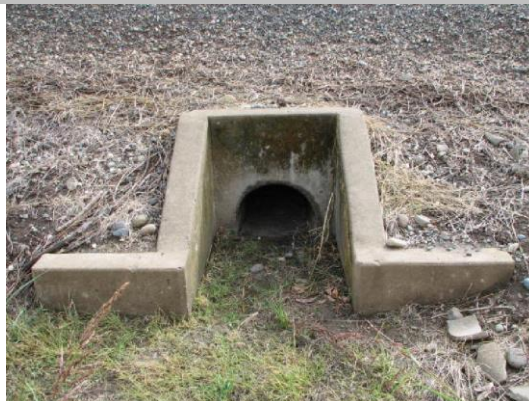
Photo 3 of 3 : UCIP\_SP\_2018\_52063\_68411.jpg

Concrete U shaped headwall on LS toe.

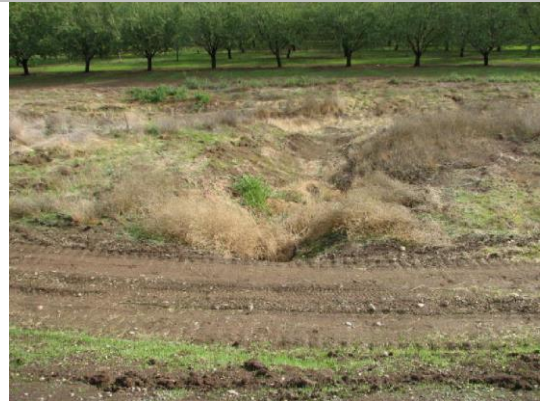
Photo 1 of 3 : UCIP\_SP\_2018\_52064\_68417.jpg

FS\_ID:52064  
DS\_ID:1666  
EP\_NO: N/A  
Repair Type: Non-Urgent  
Crossing Status: Found  
UCIP Comments: 5/18/2017 LS inlet half full of soil and WS flap gate half buried by sediment. Pipe has been selected to be internally cleaned and inspected as part of the DMP project. (DWR Sutter Yard-AFreitag)11/14/2016 LS pipe inlet is half full of soil. WS flap gate shut but half buried by sediment. (DWR Sutter Yard-AFreitag)5/12/2016 Pipe is half full of soil.7/30/2015 Pipe is 1/4 to 1/2 full of soil still.11/24/2014 Same as last inspection.6/4/2014 Same as last inspection.11/13/2013 Same as last inspection.6/6/2013 Same as last inspection.11/01/2012 Pipe 1/2 filled with soil.  
FIELD\_STRUCT\_DESC: 24-inch corrugated metal drainage pipe through the levee, 11.2 feet below the crown. Flap gate on the waterside (WS). Concrete "U" shaped headwalls on both the landside (LS) and the WS. [Additional Reference(s): DWR Levee Log, 1990. USACE Sacramento O&M Manual 516, April 1960, (Station 304+10). USACE As-Built Drawing No. 50-4-3367, Exhibit B, Sheet 3, April 1957, (Station 304+10)].

View of outlet looking toward WS toe.

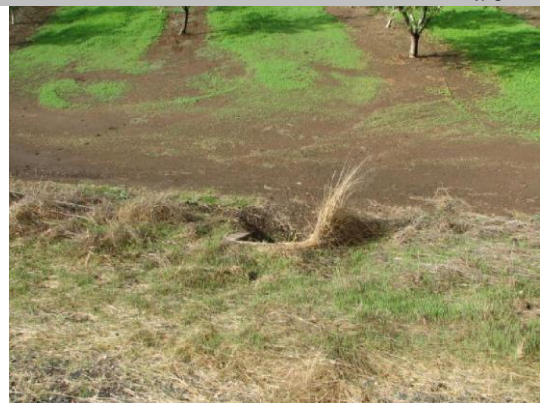
Photo 2 of 3 : UCIP\_SP\_2018\_52064\_68416.jpg

View of inlet on LS toe.

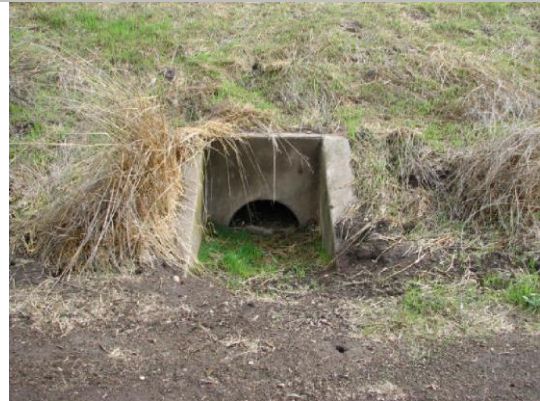
Photo 3 of 3 : UCIP\_SP\_2018\_52064\_68415.jpg

Concrete U-shaped headwall on LS toe.

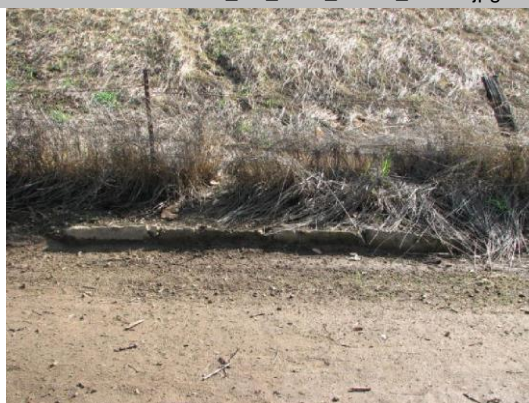
Photo 2 of 3 : UCIP\_SP\_2018\_52072\_68464.jpg

FS\_ID:52072  
DS\_ID:1673  
EP\_NO: N/A  
Repair Type: Non-Urgent  
Crossing Status: Found  
UCIP Comments: 5/18/2017 Abandoned- needs to be done properly. Pipe has been selected to be internally cleaned and inspected as part of the DMP project. (DWR Sutter Yard- A Freitag)11/14/2016 Abandoned- needs a cover for standpipe. (DWR Sutter Yard- A Freitag)5/11/2016 Abandoned crossing. Needs a cover to the WS riser.8/3/2015 Crossing appears abandoned. Only the slide gate inside riser on the WS shoulder could be found. Riser needs a cover made for it.11/24/2014 Same as last inspection.6/4/2014 Same as last inspection.11/13/2013 Slide gate top and stem were repaired to make gate operational.6/6/2013 New slidegate is planned to be installed during summer of 2013.11/01/2012 Slide gate on WS shoulder bent and damaged (inoperable) Pipe appears abandoned.  
FIELD\_STRUCT\_DESC: \*ABANDONED\* 24-inch corrugated metal drainage pipe through the levee, 14 feet below the crown. Slide gate in a corrugated metal riser on the waterside (WS) slope. [Additional Reference(s): DWR Levee Log, 1990. USACE Sacramento O&M Manual 516, April 1960, (Station 126+91)].

Abandoned headwall on LS toe.

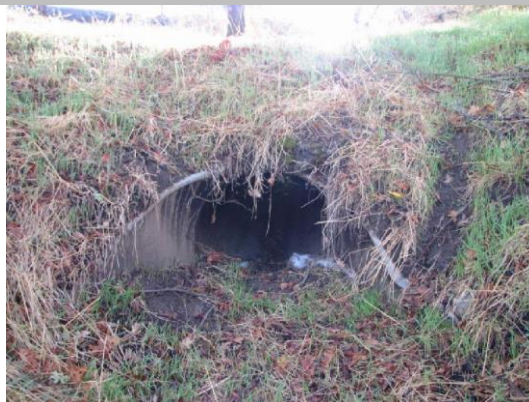
Photo 2 of 3 : UCIP\_SP\_2018\_52083\_68530.jpg

Inlet 50-feet NW of levee crown.

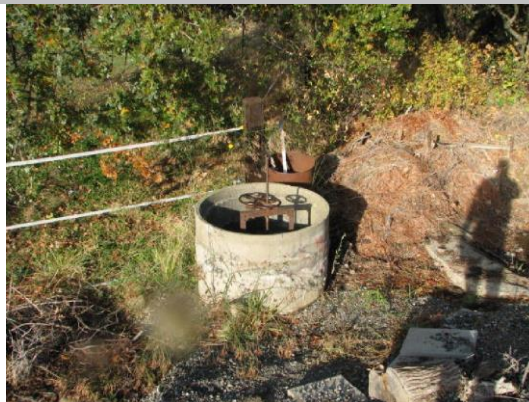
Photo 3 of 3 : UCIP\_SP\_2018\_52086\_68542.jpg

Concrete standpipe and slide gate on LS toe.

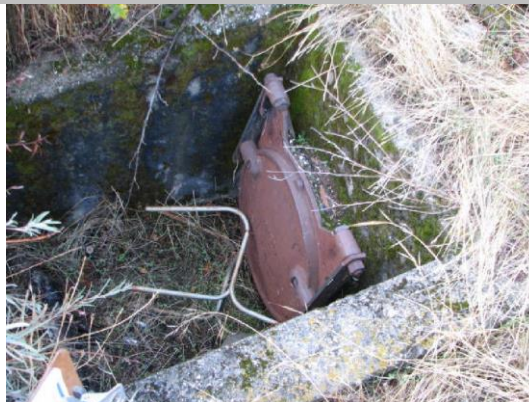
Photo 2 of 2 : UCIP\_SP\_2018\_52087\_68540.jpg

Outlet at WS toe with flap gate and concrete U-shaped headwall.

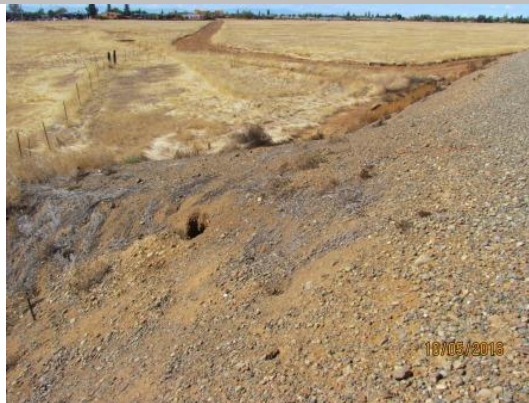
Photo 1 of 1 : SP\_2018\_MA0005\_197\_39\_20180305\_00015.jpg

LM Start	16.05	Rating **	M	Issue No.	39
LM End	16.05	Issue Type +	Ma	Location *	LS
Category	Earthen Levee			GPS Latitude/Longitude	
				Start	End
Item	Animal Control			39.714016 °	39.714016 °
				-121.782317 °	-121.782317 °
DWR ID	DWR_MA0005_02_f_2016_39				
Comment Code					
A3 : No rodents visible, but rodent burrows visible; need to backfill and compact or grout burrows.					
Inspector Comment					
Backfill and compact the rodent holes.

View of the rodent holes along the landside slope.
